Project Completion Report

Title of the project	:	Integrated Campaign for Drinking Water and Water Saving Technologies in Wangjing River Basin
Amount supported by IWP	:	Rs. 26,910/-
Location	:	Wangjing river basin of Thoubal district in Manipur.

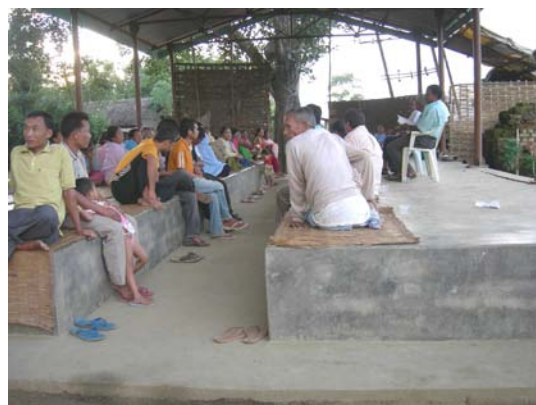
The main issues discussed in the committees meeting are-decreasing lean season flow, the shortage of water during the lean season, inappropriate ways of using available water and absence of proper institutional system to manage water resources. WWAGS contacted the senior scientist from the Environment and Ecology Wing (EEW) Imphal and requested them to conduct the Microbiological test in 3 ponds of Chingtham village. The report of the test indicates the coliform and faecal contamination of water in large scale.

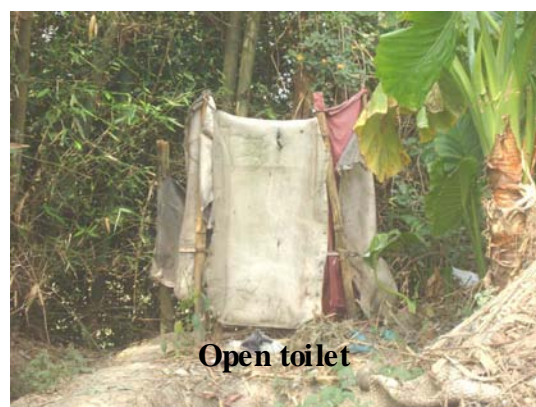
Open toilet

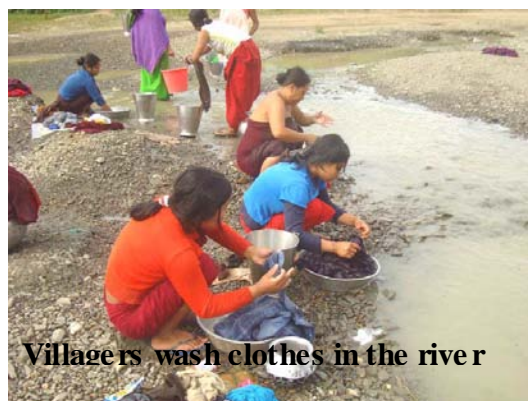
Village rs wash clothes in the river

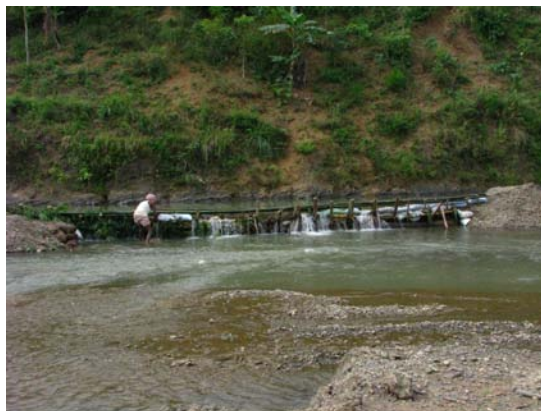
Heirolk village in the upstream get the lion share and use it for irrigation and domestic purposes. The canals and MI dams locally constructed ones are looked after by paid farmers appointed to do so. Getting water by remote villages is a matter of luck and investment. The government water supply facility in the areas is very insufficient. As reported during the discussion, the river water is diverted to the periphery villages such as Khongjom, Chingtham and Samram which are situated in the southwestern direction from Heirolk village for irrigation and drinking purposes. As there is continuous diversion of water in these villages, the people in the lower course are not getting enough water for the same purpose. As such, sometimes, there are conflicts among the people of upstream and downstream villages regarding the sharing of water.

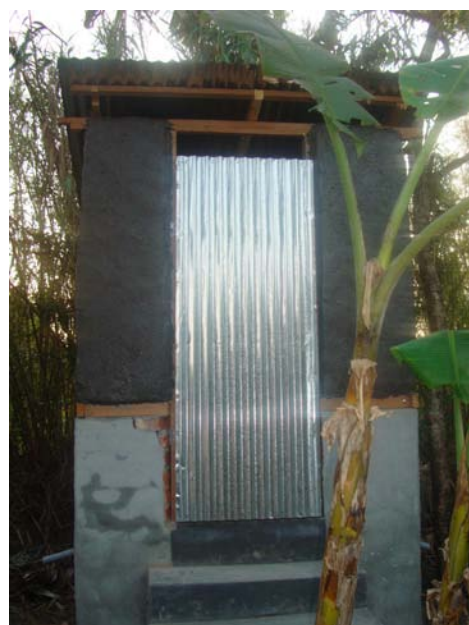
It is a three step sanitation process of containment, sanitation and recycling of human excreta. Sanitation is achieved through dehydration and decomposition.

- The Eco-san toilet consists of two chambers built on a concrete slab.
- The chambers are covered with an RCC slab with a hole over each chamber for the faces to drop in and a funnel like arrangement to collect urine.
- After defecation some materials like wood ash, lime, sawdust and soil are added to cover the faces. It takes an average family, six months to fill one chamber.
- The second chamber is then used. The first chamber is emptied after another six months when the second chamber is full.
- The contents are then stored and used as manure.
- Urine collected separately in a can is diluted and uses as fertilizers.

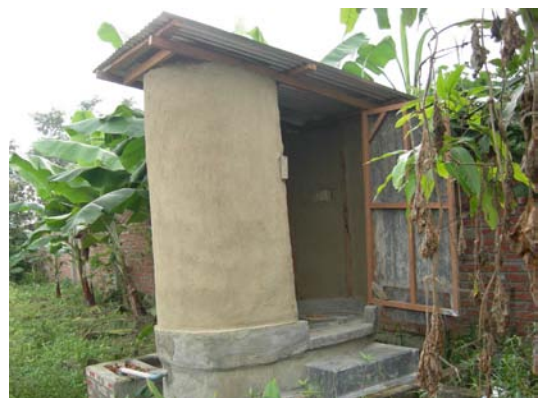
Considering the above given points, an ecosan was designed at Wangjing village under which the rectangle shape of earlier was replaced by round and oval shape and filter chamber for back waste water was added. Under this designed the cost of ecosan was reduced to Rs.9500. Due to difference in human anatomy between male and female, some drops of urine was fallen in the pit when women used the toilet. Excreta hole cover was suggested under the research project to avoid falling of urine in the pit. Cleaning of toilet with water was allowed comfortably as excreta hole cover made available and vertical gas out was also checked. Height of the excreta tank was reduced to two and half ft so that the children and aged persons could use it easily
