## Water & Climate Resilience Programme (WACREP), India

### Report on Water Bodies and its Vulnerability with Basket of Sustainable Adaptation Options

**Activity No. 3.7.1.C (Work Package-7) : Assessment of vulnerability to climate change on water resources, commons, agriculture system and animal husbandry in Sinhar watershed in Bhinder Block (Vallabh Nagar Tehsil) in Udaipur district of Rajasthan**

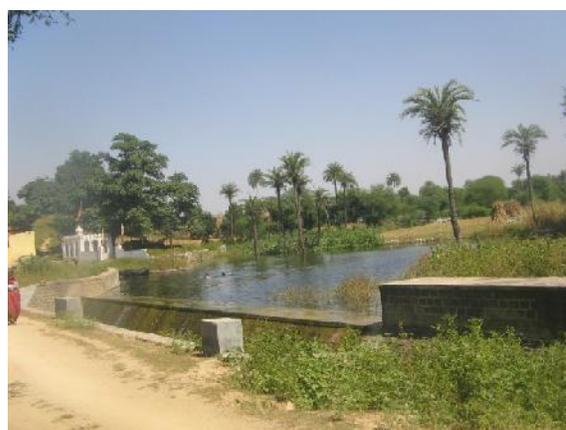
**Table 4 Surface water bodies in project villages**

The project villages are generally located in the undulating and hilly terrain and therefore surface water storages are limited in number and extent. The monsoon runoff is generally stored in the small water harvesting structures (ani cuts) and in the village ponds and Nadies, wherein water remains for a few months after monsoon. The area does not have any minor or major irrigation project to support agriculture, though some of the water harvesting structures is used for lift irrigation for limited area. The following table depicts status of surface water bodies in the project villages.

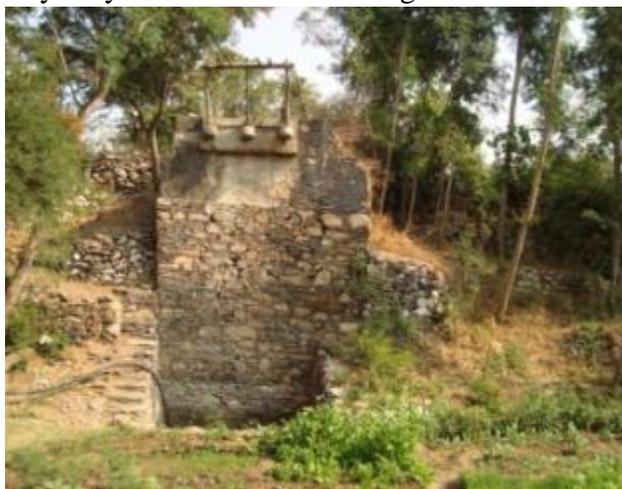
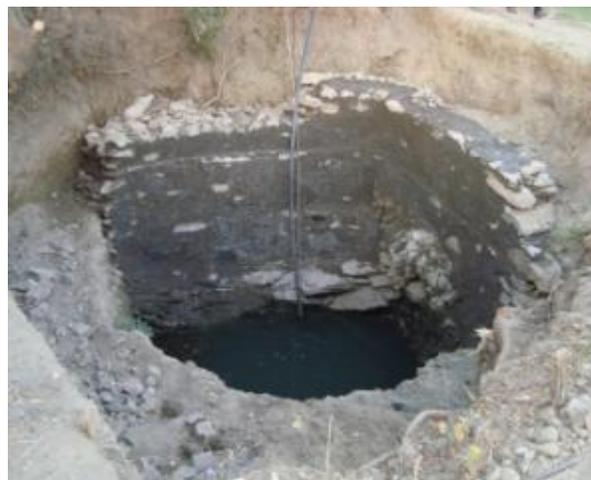
The depth of wells generally depends upon their geomorphic location and hydrological conditions corresponding to encounter of water table. In valley portions and along stream courses the wells are of shallow depth as the water table is nearer to the ground level as compared to the hilly regions where it is deep therefore, the wells are also deep in this region. The depth of wells may vary from 8 meters below ground level to 34 meters.

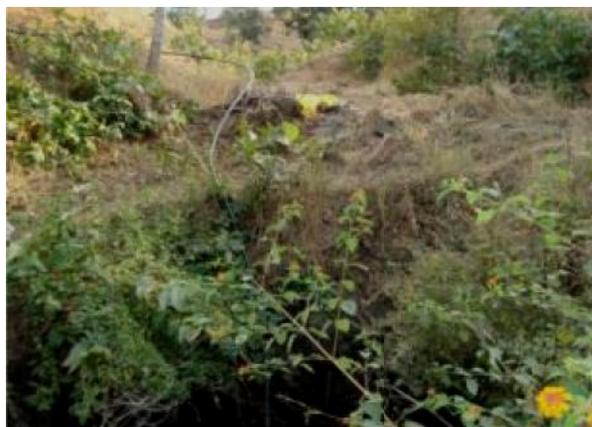
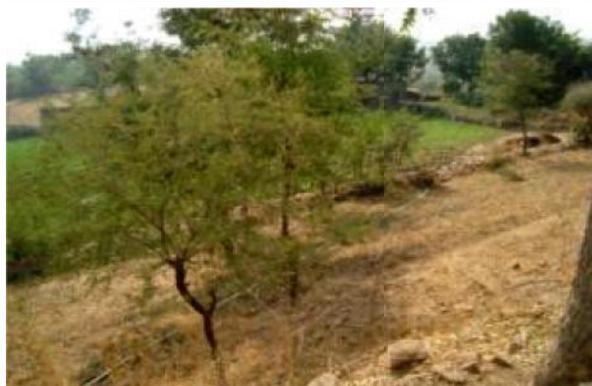
The agriculture land is located at different elevations, since the area is undulating, therefore wherever the fields are on higher elevations the water is lifted from the wells that are located in the valley or along stream

courses, through the plastic pipes although the head increases by 30 to 40 meters, but the availability of water for irrigation is ensured. The water is sometimes transported even up to 1500 to 2000 meters from wells to agriculture fields. It is a cumbersome exercise for the farmers during irrigation season but there is no alternate system is available like lift irrigation schemes or overhead tanks from where water can be distributed to fields.
